# DUNLOE CASTLE

Architects: Howley Hayes Architects  
Engineer: Lisa Edden  
Contractor: Conservation & Restoration

## An Illustrated Guide

## CONSERVATION WORKS

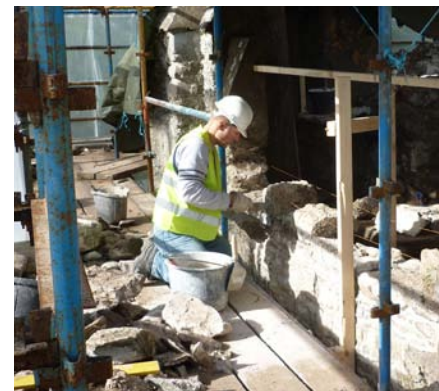
Parapet being rebuilt by Conservation & Restoration

The repair works involved the removal of the ivy, repair of the stonework to the battlements, fireplaces, window openings and the installation of a lightweight steel gangway and staircase. All of the repair work was carried out using traditional techniques including the use of lime

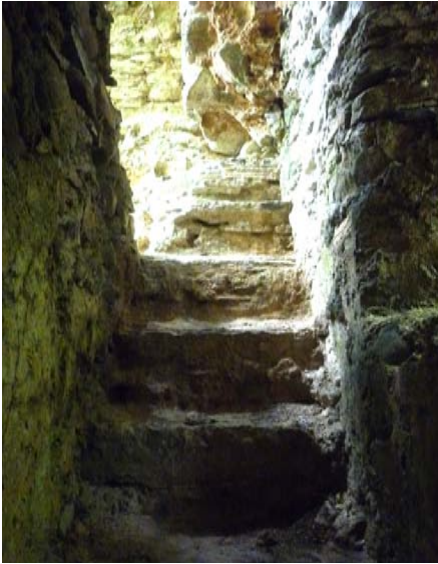
View up the mural staircase prior to conservation repairs

mortars. These are softer than the cement mortars used to repair the building since the middle of the twentieth century, which led to cracking and damage to the original stonework. The installation of the new staircase involved considerable precision and ingenuity, demonstrating the need for the best traditional and modern techniques in the successful conservation of historic buildings.

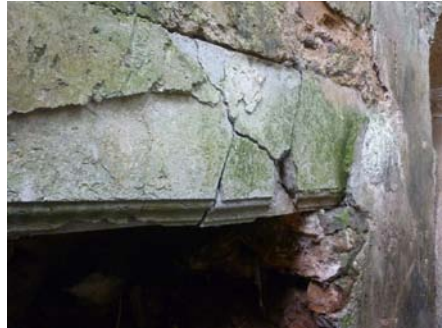
Detail of carved stone fireplace prior to repair

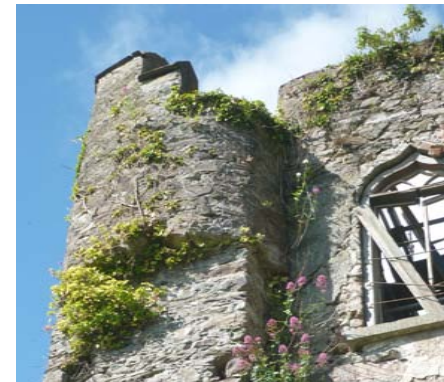
Detail view of curved bartizan to SE corner

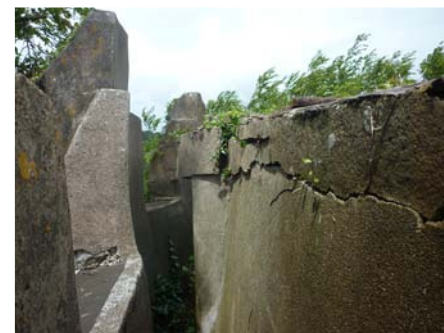
The building was in a very poor structural state, with many areas of unstable masonry at high level. The battlements had been rendered with hard cement which was now cracking badly. This was caused by frost action and damage by tree and ivy roots. All of the window lintels were in poor condition and in danger of collapse, and the timber windows were beyond repair. A new eighteenth-century style front door and a replica window were installed in the south facade.

View of the parapet prior to conservation repairs

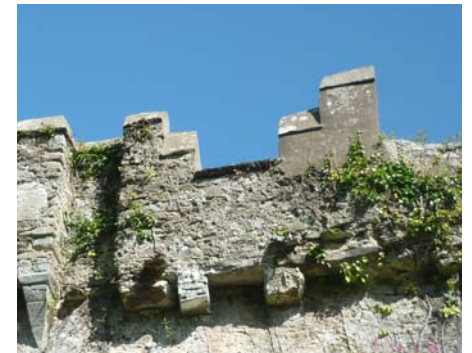
Detail view of drip stones & machicolations to south parapet

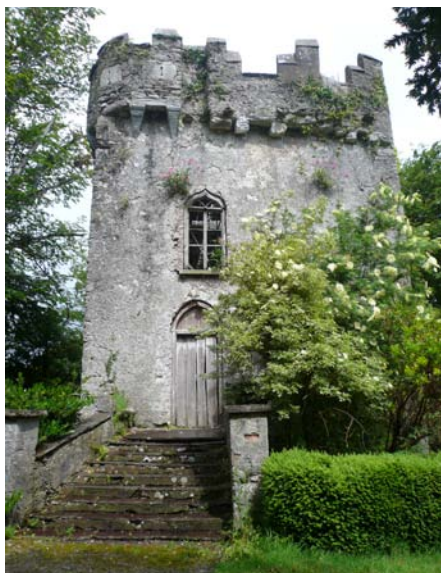
View of the south facade and main entrance

first floor level. Probably created during the late eighteenth or early nineteenth century, the current entrance on the south side is approached by a broad flight of stone steps. A *bartizan* on the south east corner together with *machicolations* on the parapet suggest a typical Irish tower house from the late fifteenth or early sixteenth centuries. However, the masonry pattern of the lower two storeys, together with the steep mural staircase contained within the west wall rising from beside the original first floor entrance, suggest that significant portions of the thirteenth-century structure remain.
